# Manhole Inspection Summary

Manhole # S17K\_\_058MH

Insp Date: **4/8/08 8:48 AM**

**Location** Address: **2537 emerson-pratt alley**

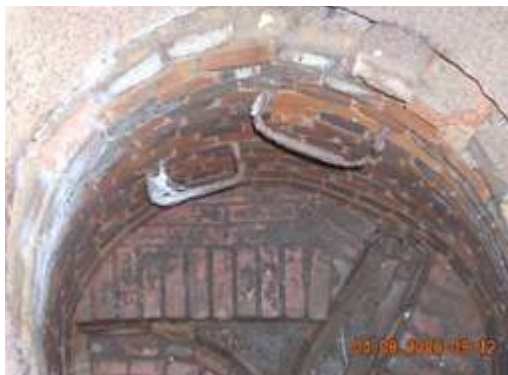
Defect 3

**Steps** Count: **2** Missing: **0** ☒ **Corroded**

corroded steps

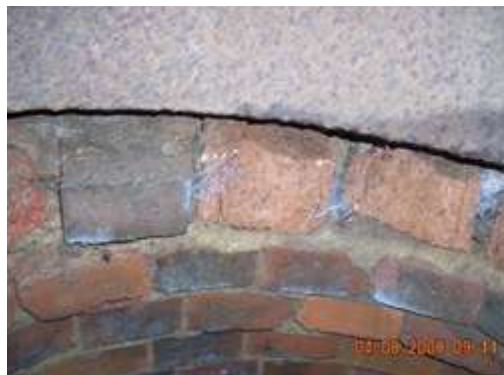
Defect 2

Condition: ☐ Sound ☐ Cracked ☐ Root Intrusion ☒ **Loose Brick** ☒ **Deteriorated**

deteriorated chimney bricks

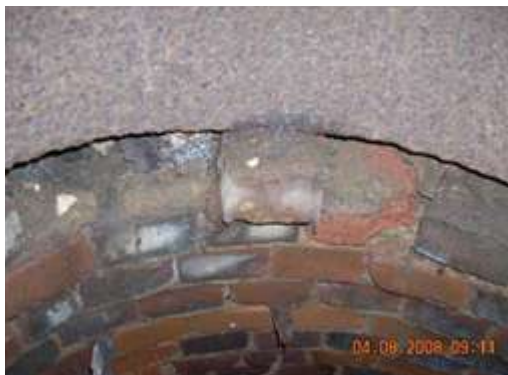
Defect 1

loose chimney brick

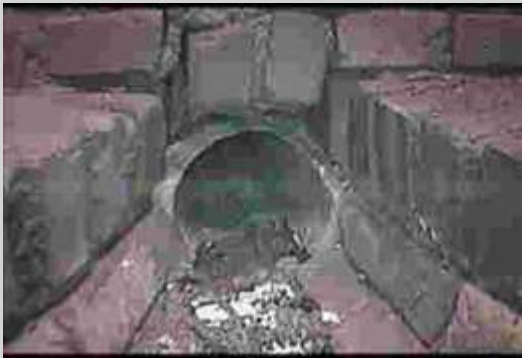
12 O'Clock Outflow

Pipe Height: **6** (in.) Rod and Bar (Angled)  
Pipe Material: **Clay** ☐ Pipe Lined  
Invert Depth: **5.10** (ft.) Flow Characteristics: **None**  
Deposits: ☒ None ☐ Mud ☐ Sludge ☐ Debris ☐ Grease  
Silt Depth: **0** (in.) Deposits Extent:  
Infiltration: **None** Pipe Seal Cond: **Cracked**

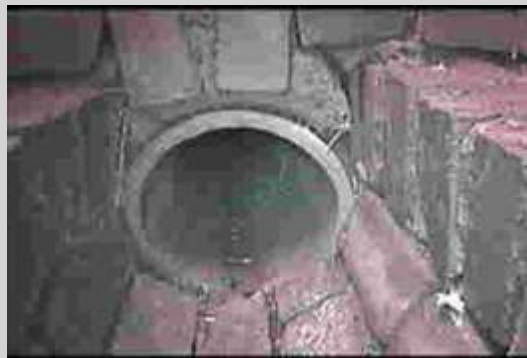
7 O'Clock Inflow

Pipe Seal Cond: **Cracked**
